**U.S. EPA REGION VIII
TECHNICAL ENFORCEMENT PROGRAM
RCRA COMPLIANCE EVALUATION INSPECTION REPORT**

Facility: Frontier Refining, Inc.
2700 East 5th Street
Cheyenne, WY 82007

Inspection Type: Corrective Action Compliance Inspection
For Pond 2 Clean-Out

Date: October 31, 2011

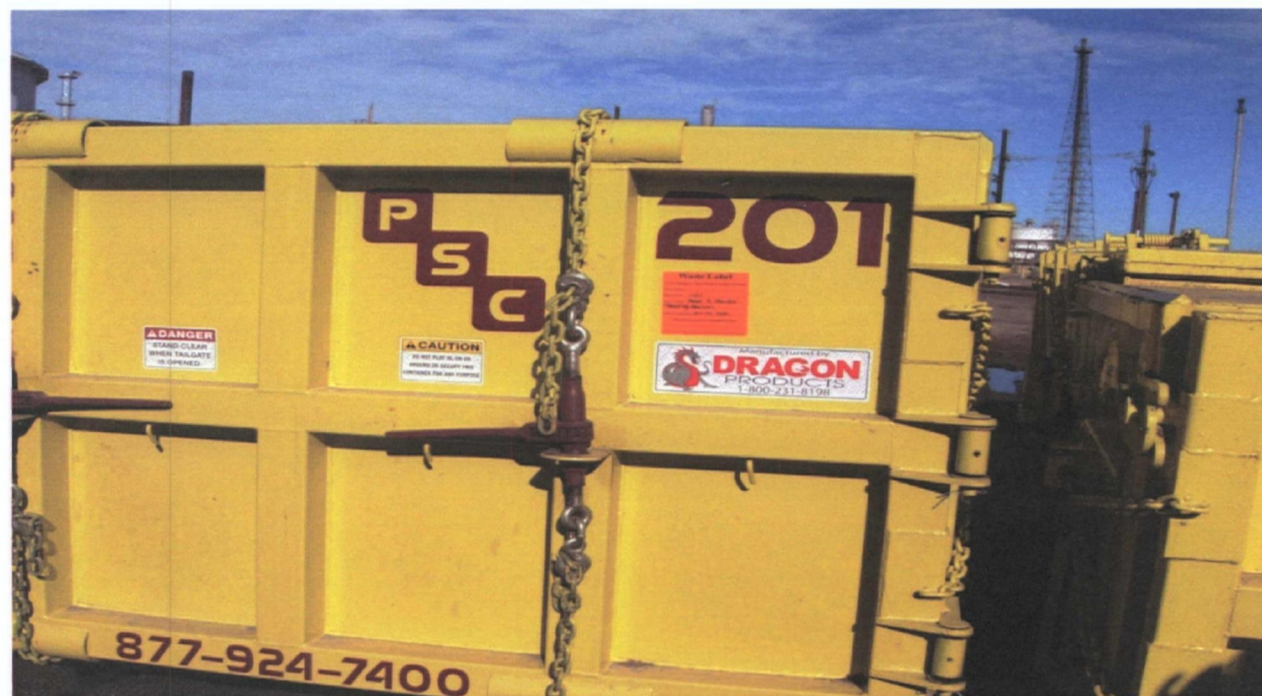
Photo: 27
Facility: Frontier Refining
Subject: Roll-off Containing
Pond 2 Wastes
Photographer: Linda Jacobson
Date: October 31, 2011

Ms. Jacobson was shown the materials removed from the pond. The oil-contaminated concrete will be sent to a non-hazardous landfill. The soft-top rolloffs contained the Pond 2 synthetic liner and were labeled as "Pond 2 Liner Pending Analysis 10/20/11". There were three hard top roll-offs which were labeled as "Pond 2 Sludge Pending Analysis 10/24/11". These three roll-offs contained the geofabric as well as the stained sand and soils removed from between the synthetic and clay liners.
